Base Realignment and Closure (BRAC) Cleanup Plan

**Fort Devens
Fort Devens, Massachusetts**

AUGUST 1995

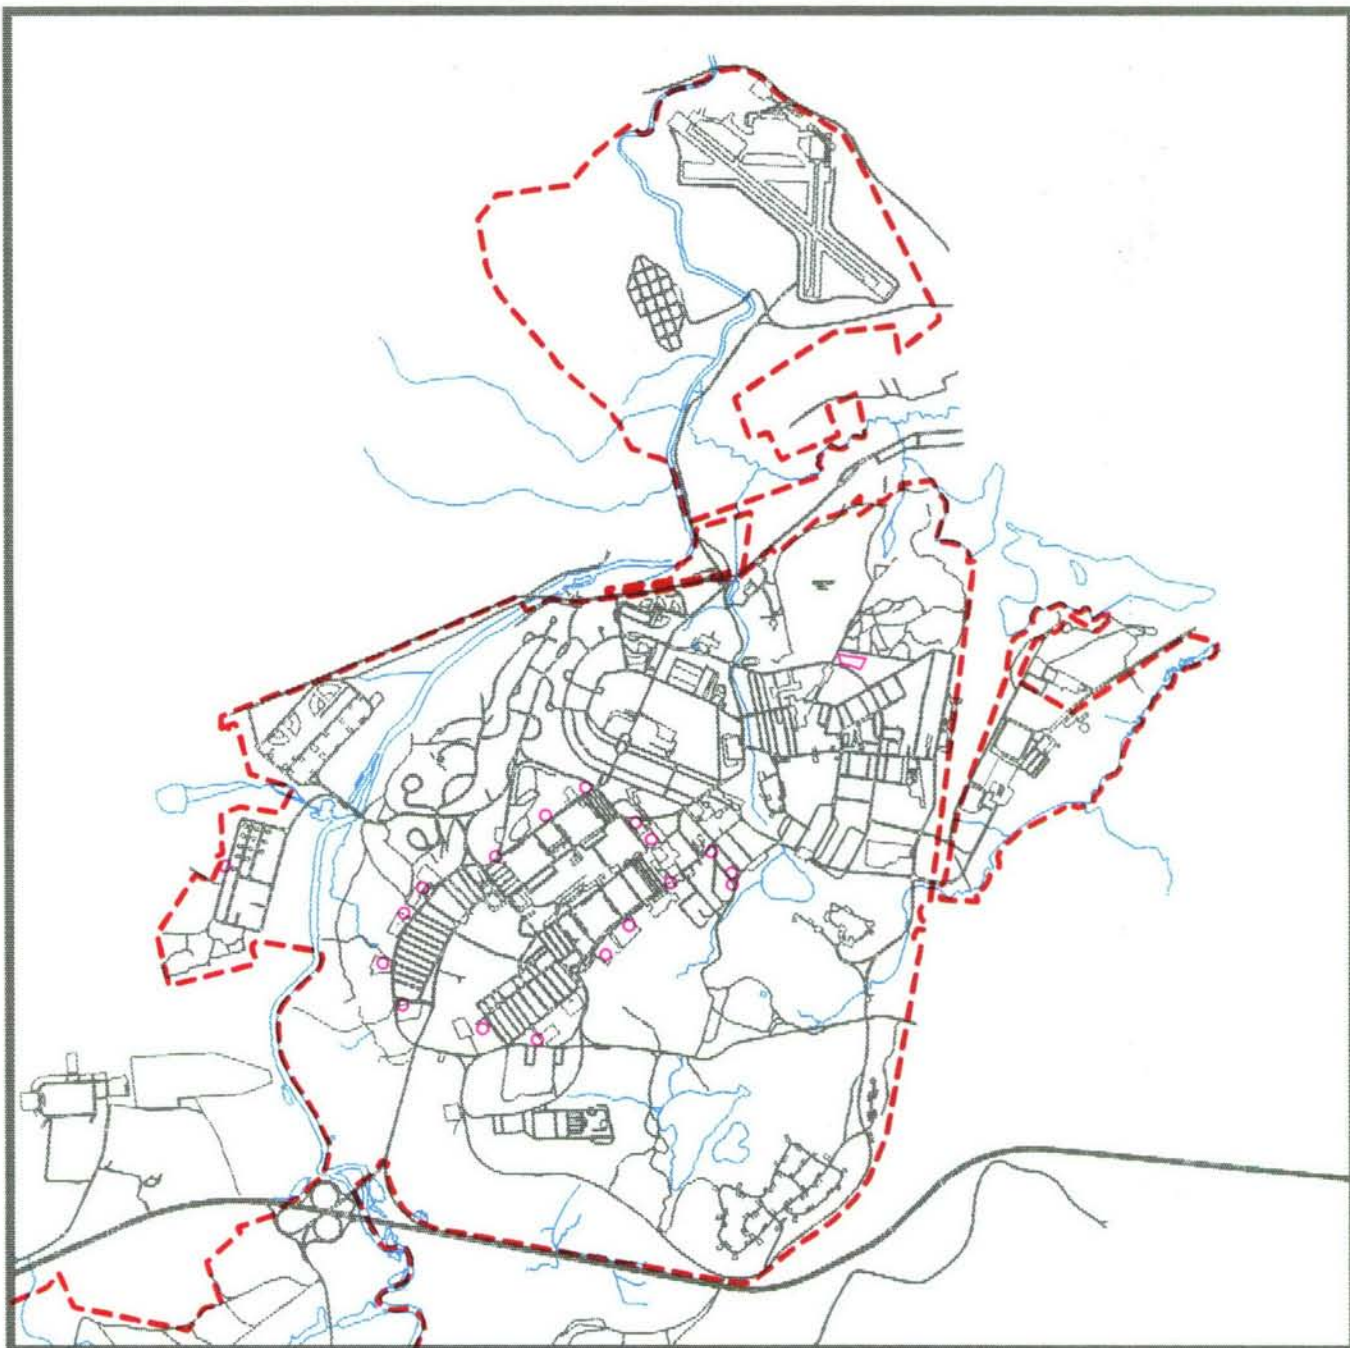
Figure 1-3A

Location of Past
Hazardous
Substance
Activities
North and
Main Posts
Reference 1.

Note: See Table 1-4 for hazardous substance activities reference number explanation.

Several activities involving the handling of hazardous substances and petroleum, oil, and lubricants (POL) have occurred at Fort Devens throughout its history. These activities include fuel oil storage and distribution, motor pool and service station operations, maintenance of vehicles, aircraft, and small engines, photographic processing, and landfilling. Table 1-4 identifies the hazardous substance activities conducted at Fort Devens. Figures 1-3A through 1-3D show the locations of these hazardous substance activities.

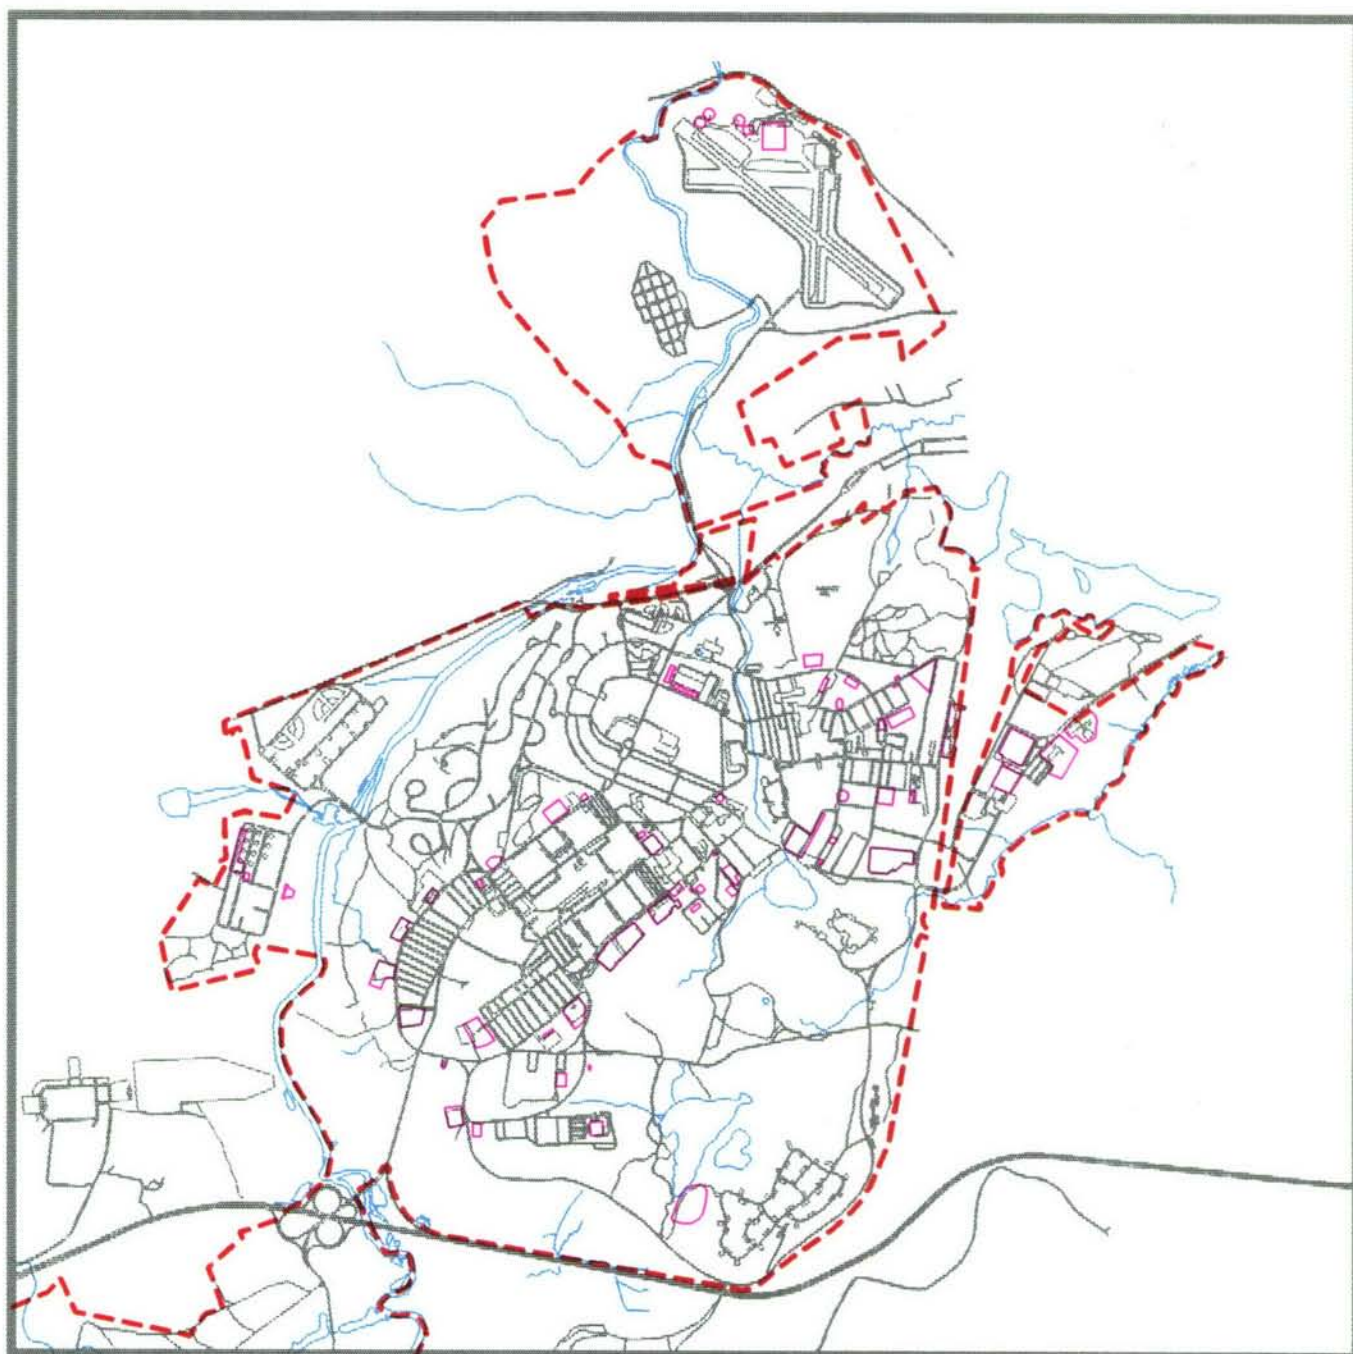
Figure 1-3B

Location of Past
Hazardous
Substance
North and
Main Posts
Activities
Reference 2

Note: See Table 1-4 for hazardous substance activities reference number explanation.

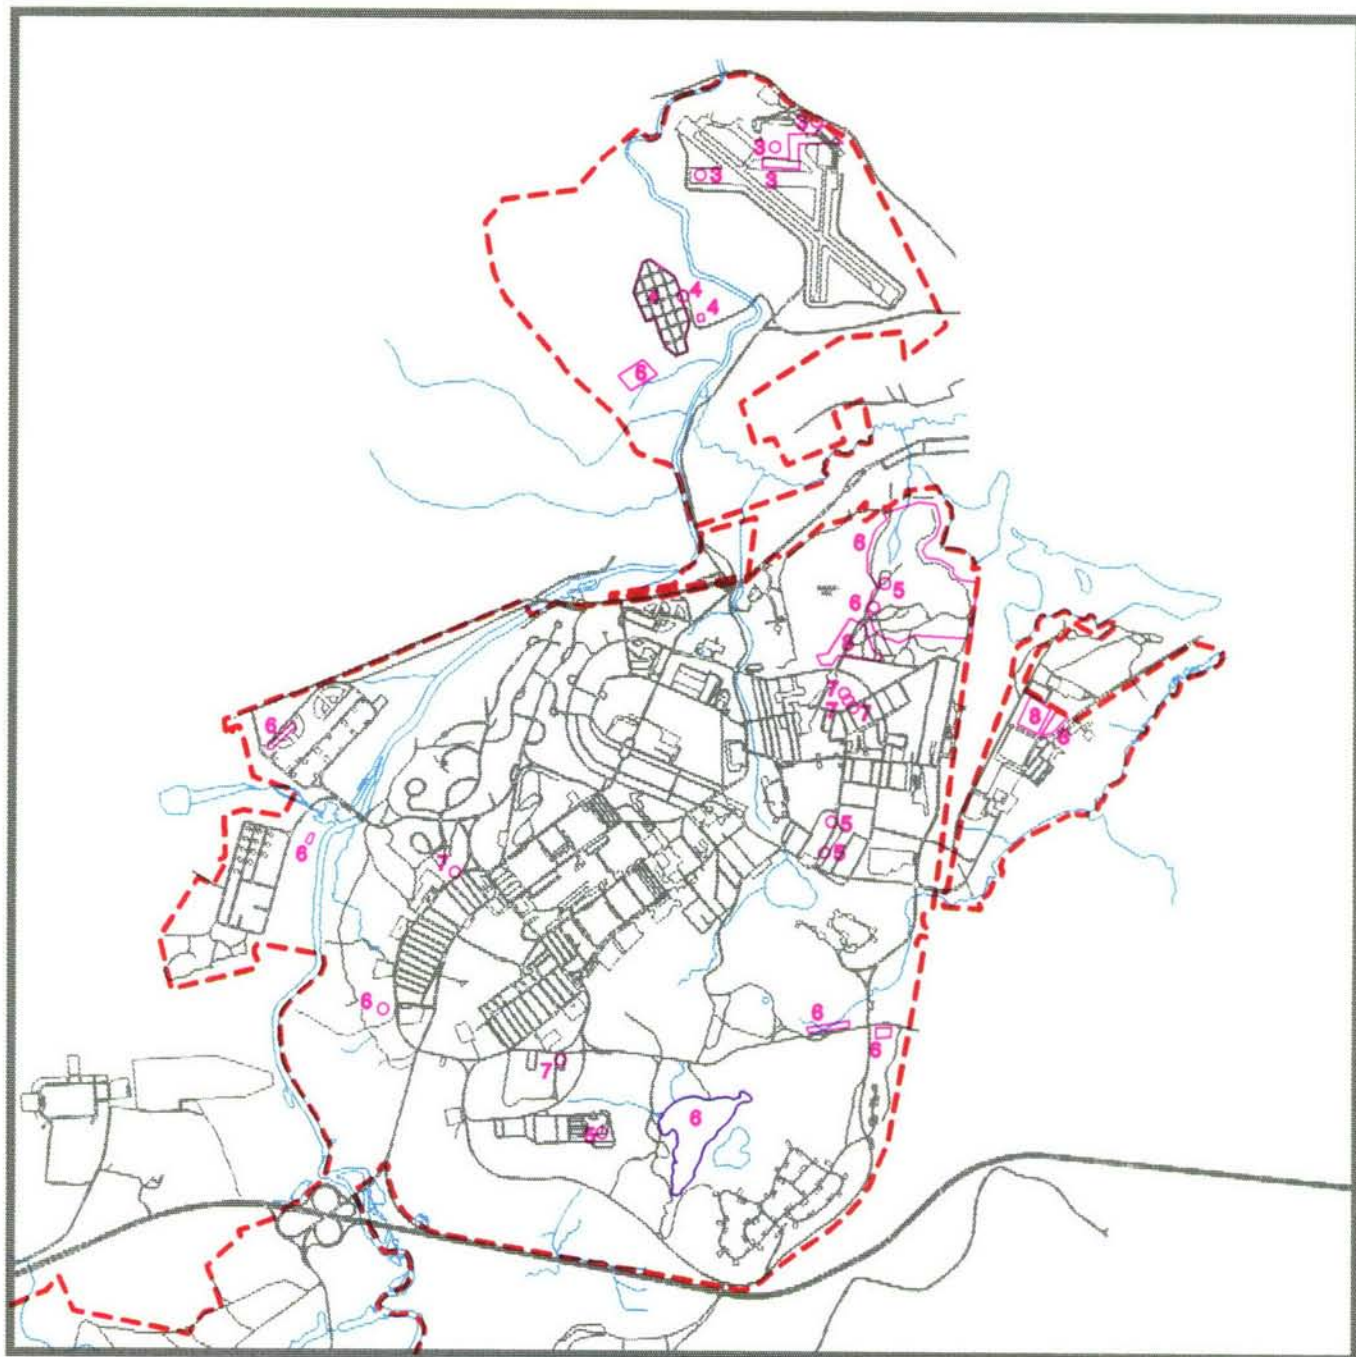
Location of Past
Hazardous
Substance
Activities
North and
Main Posts
References 3-8

Note: See Table 1-4 for hazardous substance activities reference number explanation.

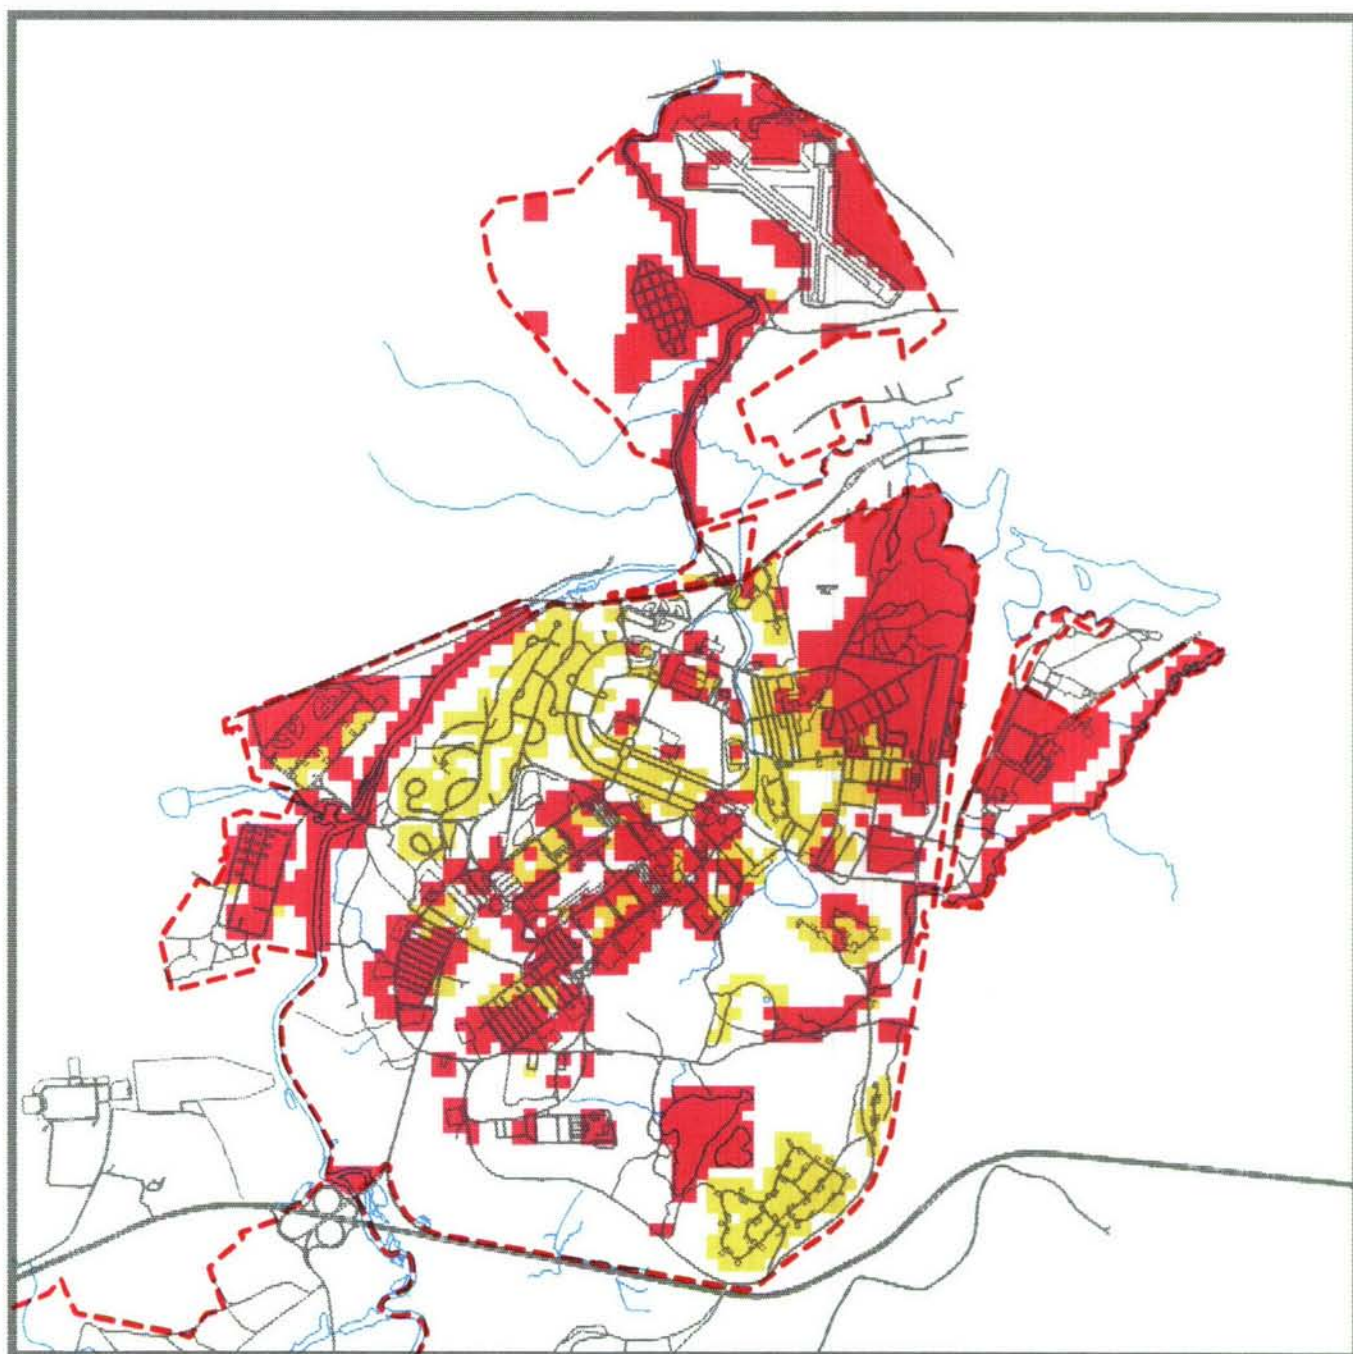
- Installation Boundary
- CERFA Parcel
- CERFA Parcel with Qualifier(s)
- CERFA Disqualified Parcel
- CERFA Excluded Parcel

Environmental
Condition
of Property

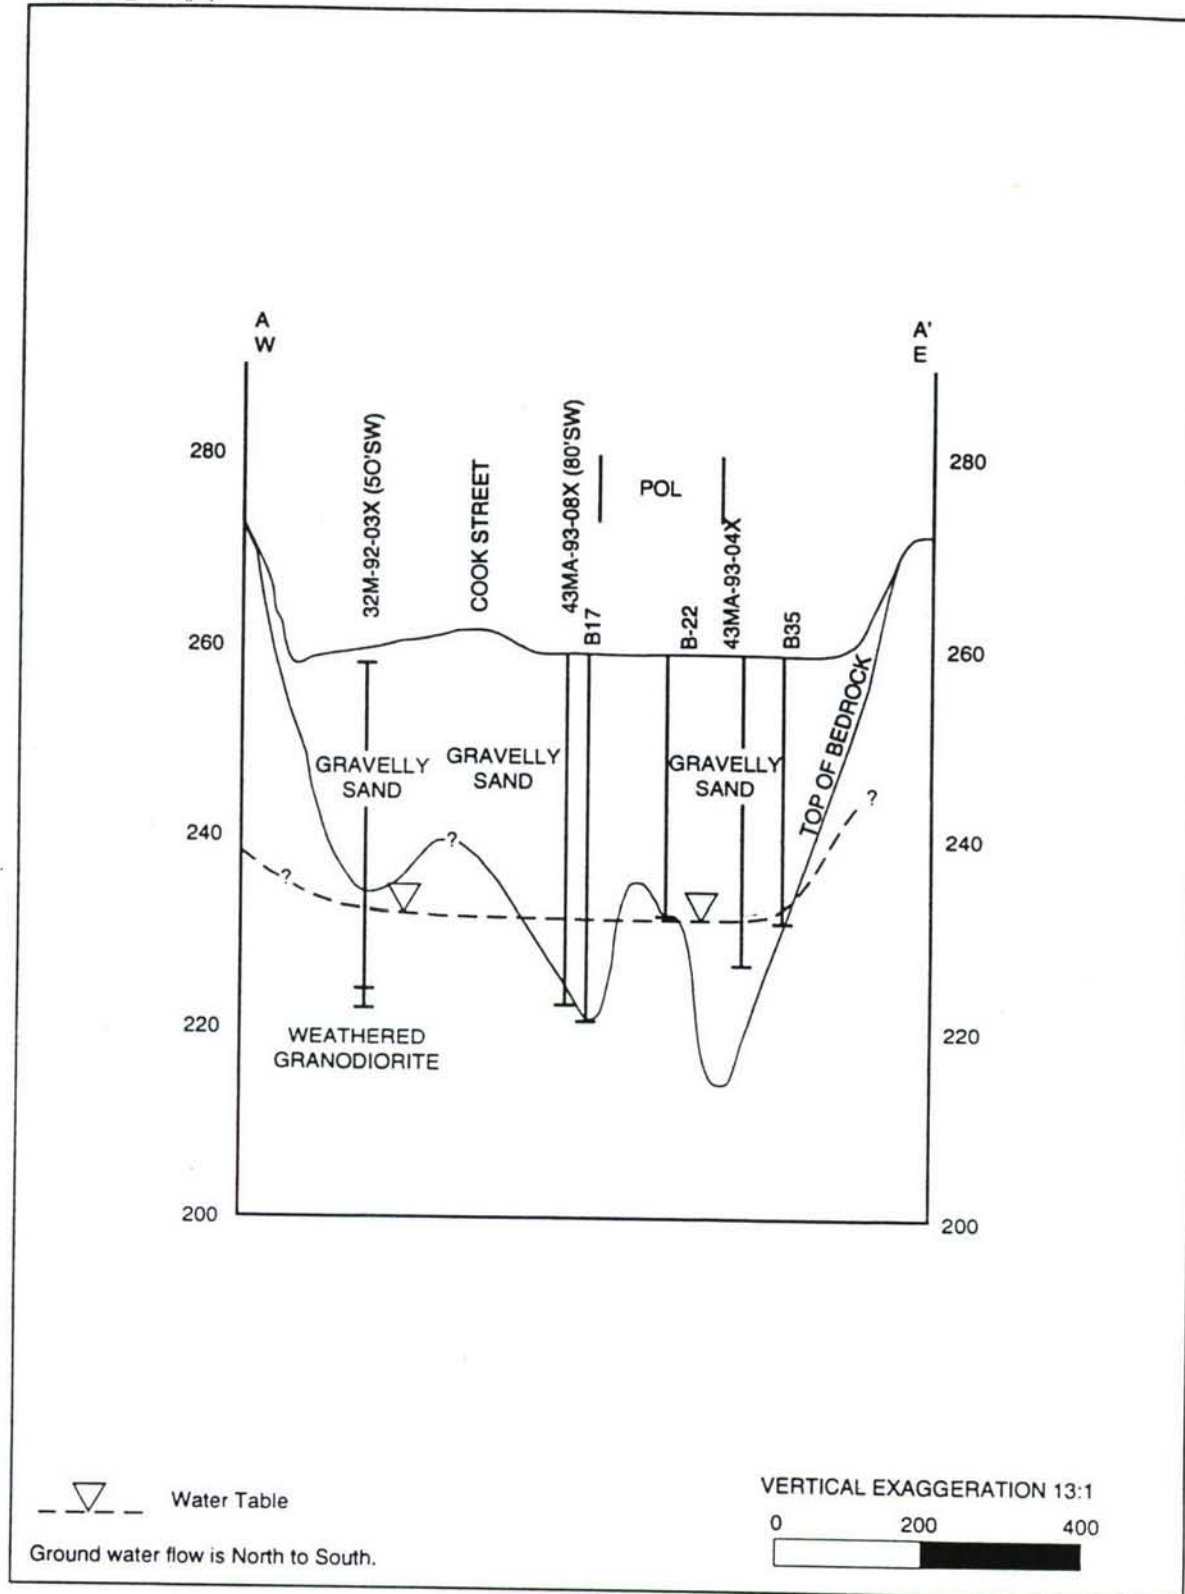
**Figure E-2.4A CONCEPTUAL SITE MODEL DATA SUMMARY
POL AREA (AOC 43) CROSS SECTION VIEW A-A'**

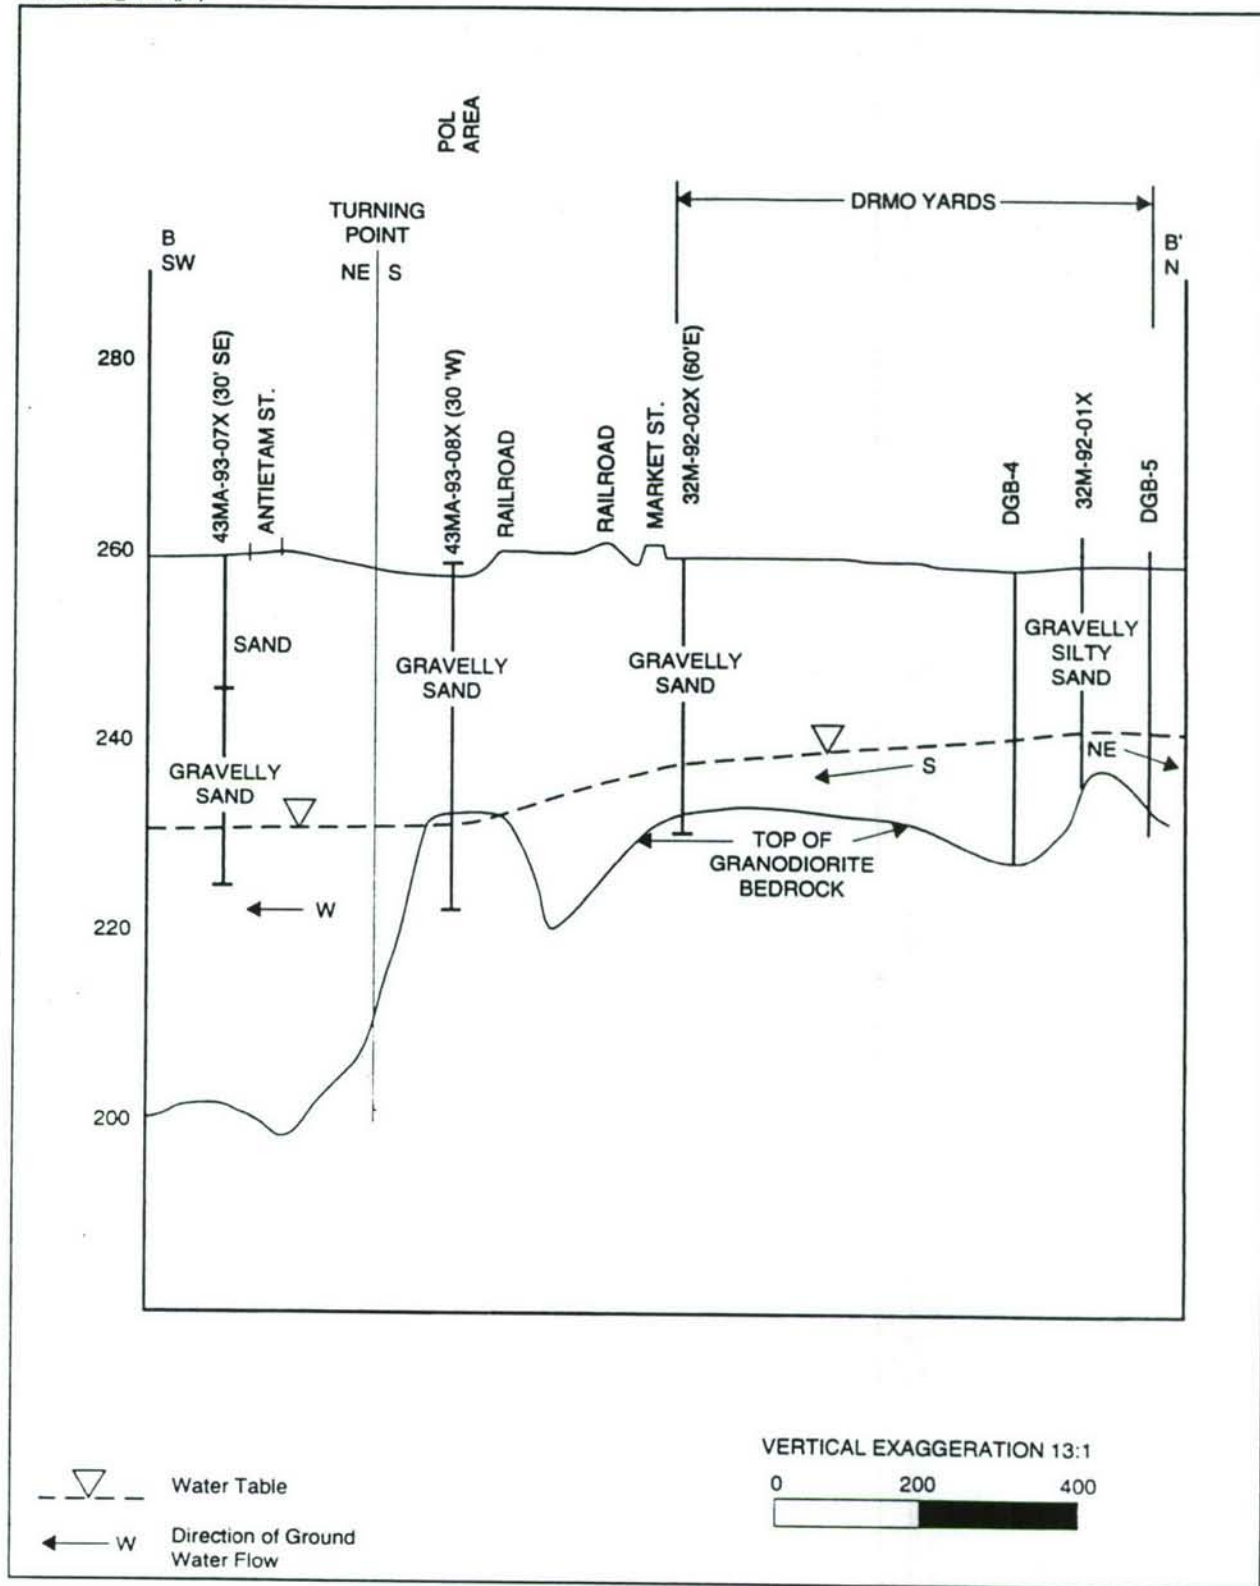
**Figure E-2.4B CONCEPTUAL SITE MODEL DATA SUMMARY
POL/DRMO (AOC 43/32) CROSS SECTION B-B'**

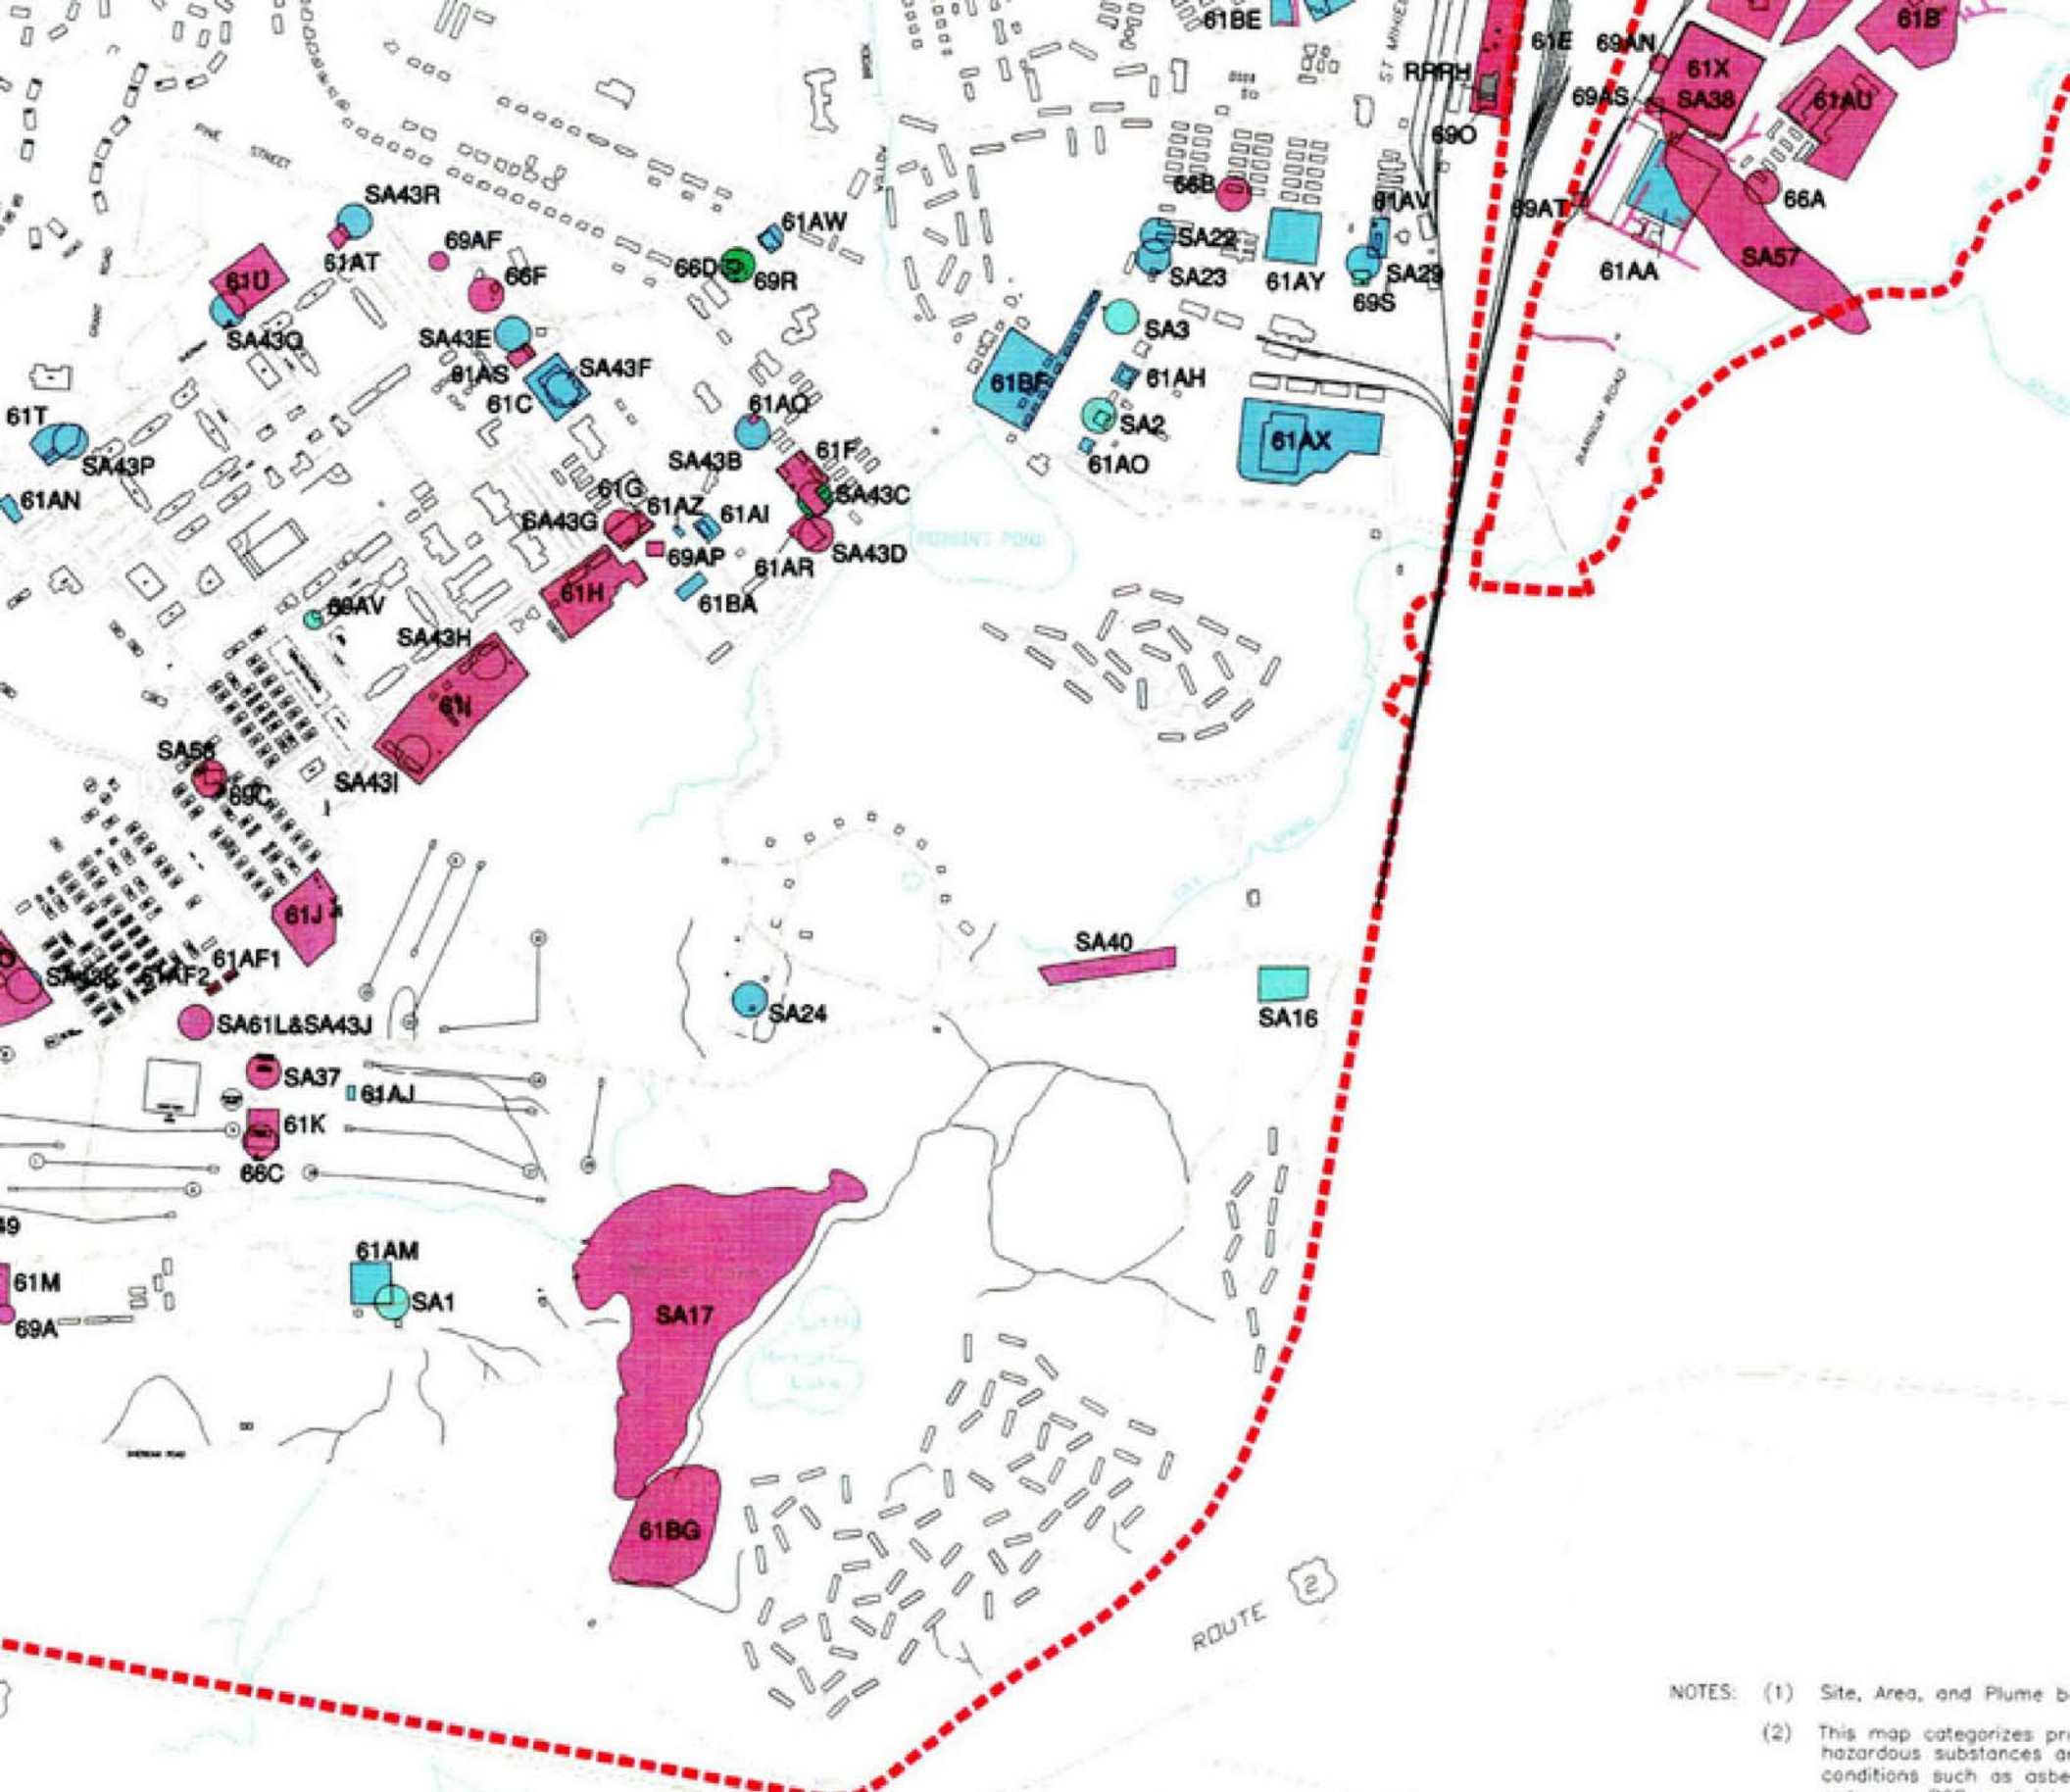
- NOTES: (1) Site, Area, and Plume b
- (2) This map categorizes pri
hazardous substances a
conditions such as asbe
radon, or PCB containi
property. The presence
are shown in the Enviro
- (3) The precise location and
at Fort Devens are not
sites are identified in th
BRAC Office for informat

boundaries and UST/AST locations are approximate.
